# SRX LP

LANDFILL PUMP

# SRX LP Landfill Pump

**The SRX LP Pump was removed from the well for inspection and cleaning after five months of trouble free operation.**

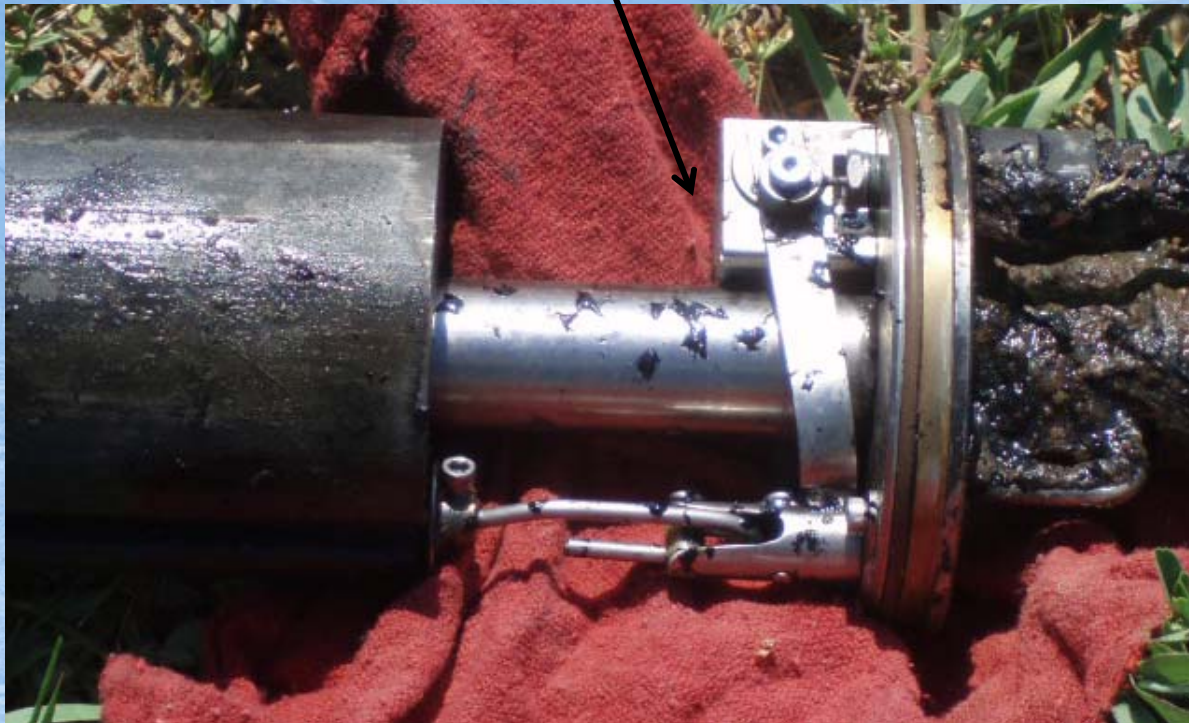
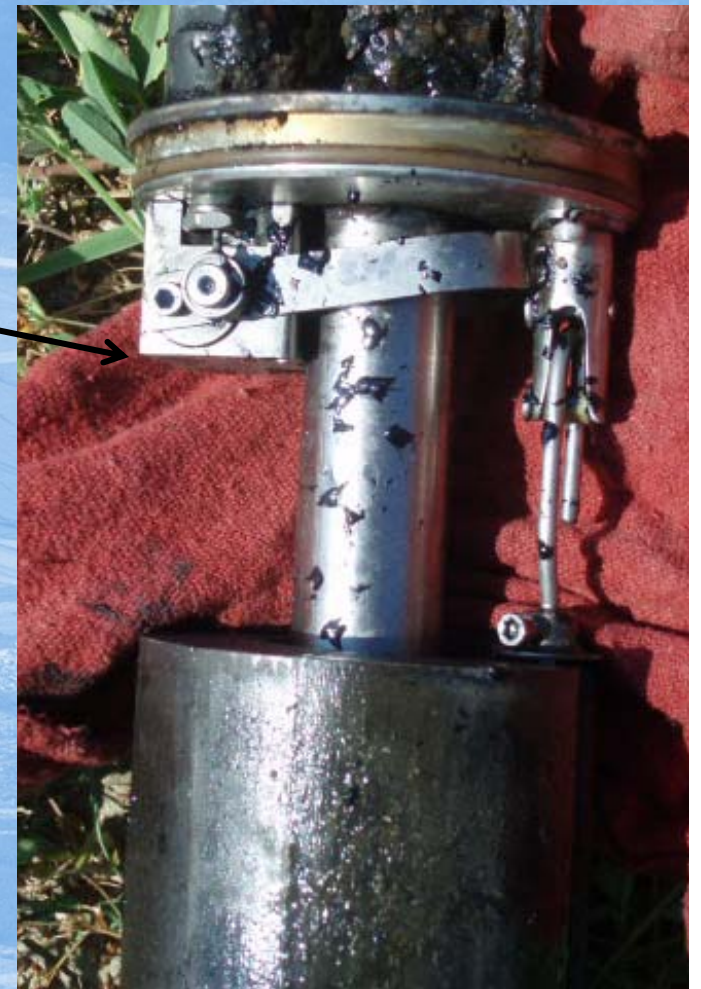
Minimal build-up has occurred around the air valve and pump linkage. This is attributed to the positive air valve seal

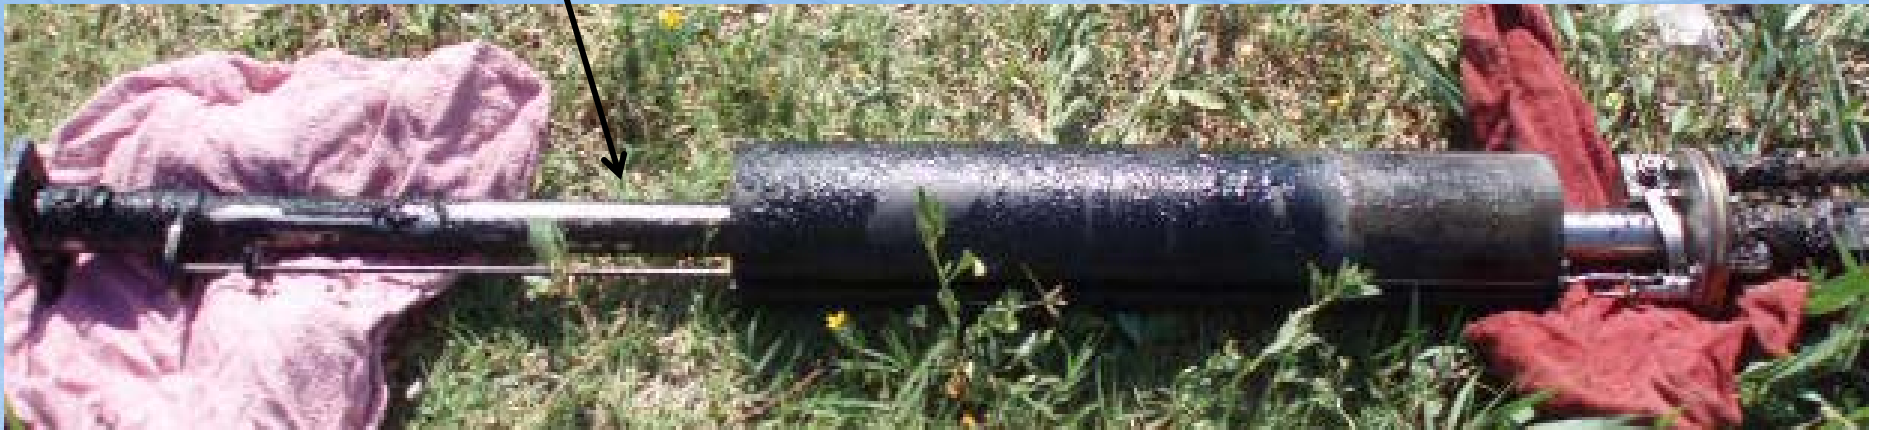
Minimal build-up occurred on the center discharge tube. This is primarily due to the polished OD of the discharge tube and the movement of the hard surface Ebonite Float

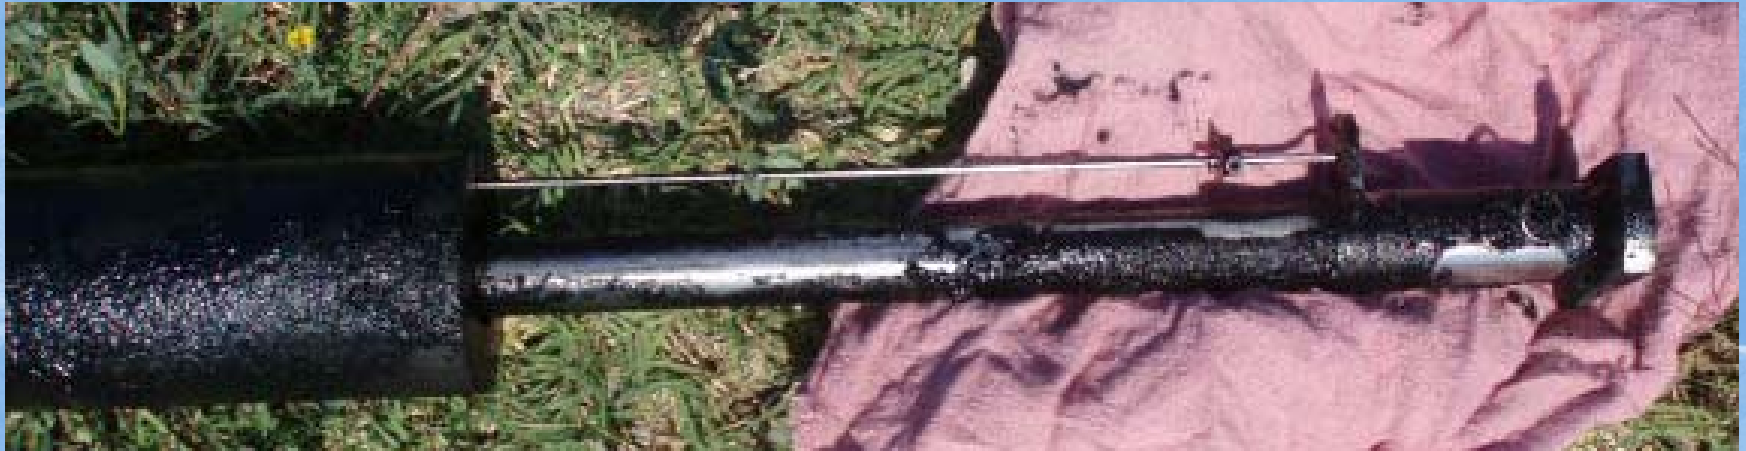
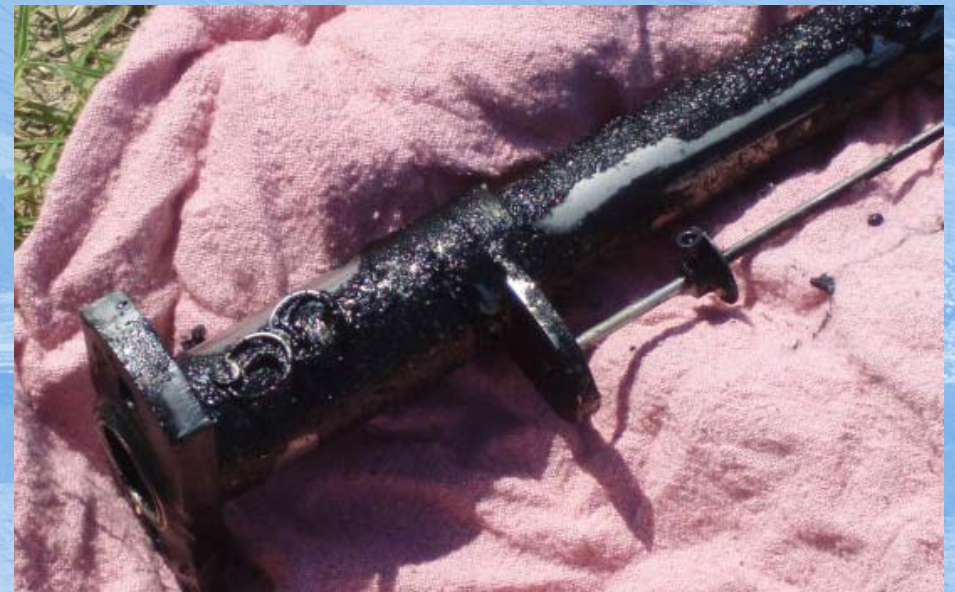
**Build-up on the float OD and at the bottom of the arch assembly. The hard/slick surface of the float allowed the build-up to be wiped away with a light solvent and shop cloths**

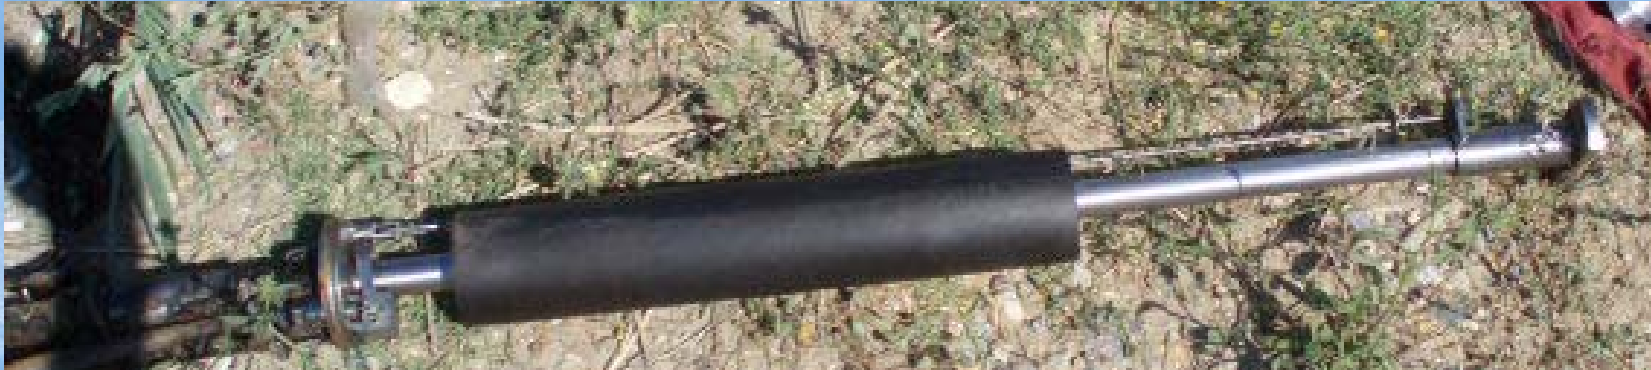
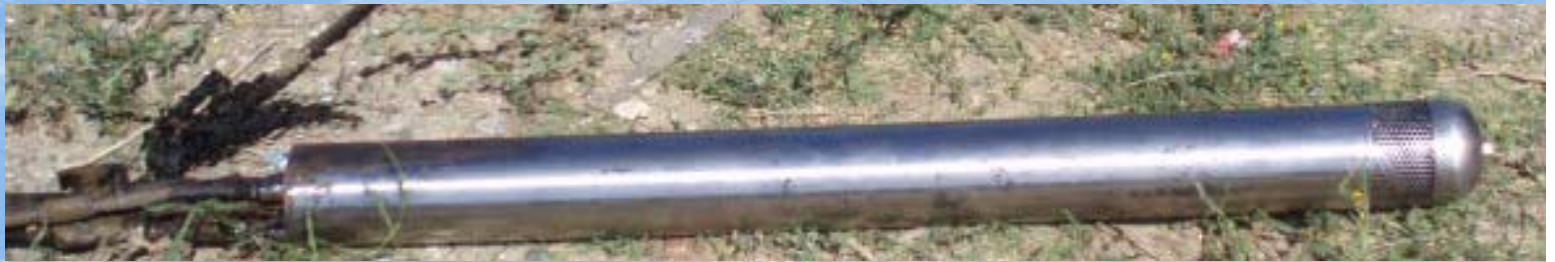
**The Pump was completely disassembled - cleaned and reassembled in the field. Since the float and control rod are easily removed cleaning was accomplished by wiping the pump with shop cloths and a light solvent in less then 30 minutes**
