Chlorofluorocarbon (CFC) Remediation Case Study

Los Angeles California

Project Description

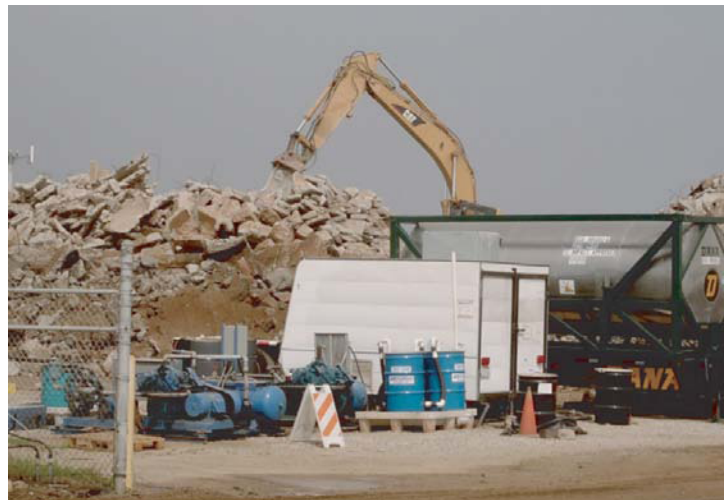
The SVE system primarily targeted volatile organic compound (VOC)-impacted soils beneath the former refrigerant plant and the immediate surrounding areas. The site had begun redevelopment during SVE remediation as shown in the site photo.

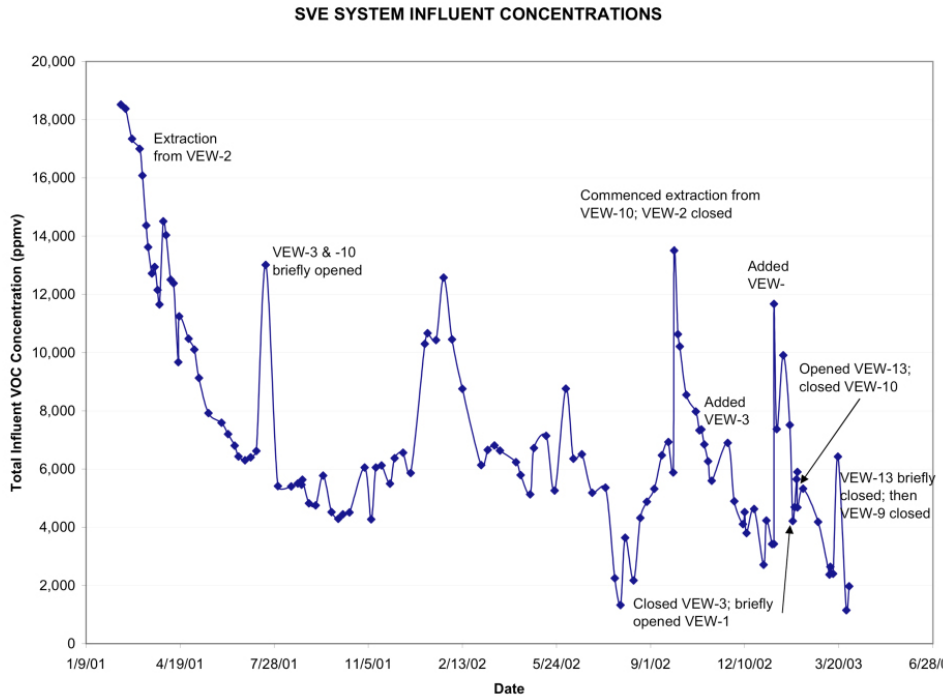
Vapor Treatment System Design

- 200 SCFM system
- Ten vapor extraction wells were operated in cycles
- Maximum initial concentration achieved was 18,524ppmV

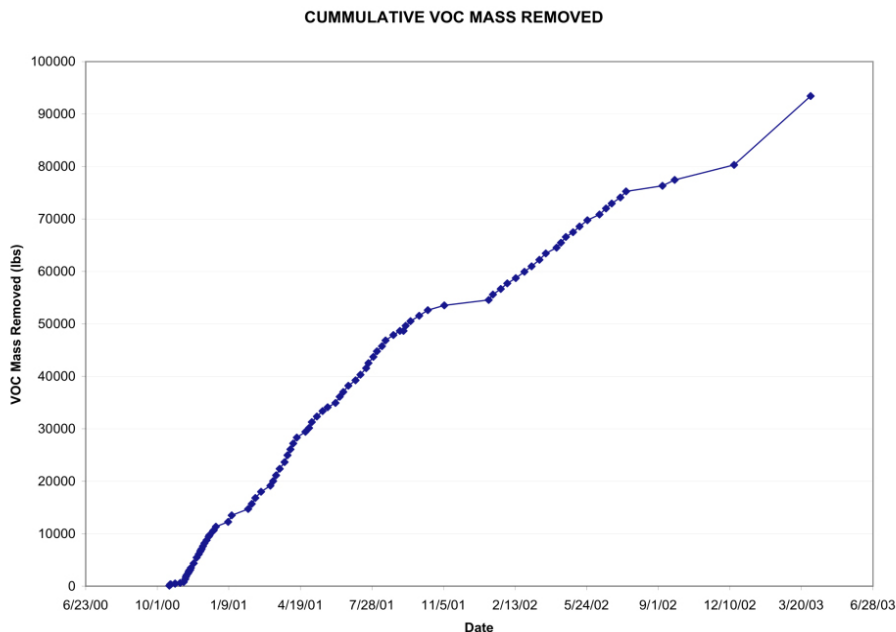
System Performance and Results

93,422 pounds of chlorinated solvents were recovered in 27 months.
