## MOBILE REMEDIATION UNIT - MPVE / SVE / PILOT TRAIL TRAILER MOUNTED

### PROCESS DIAGRAM

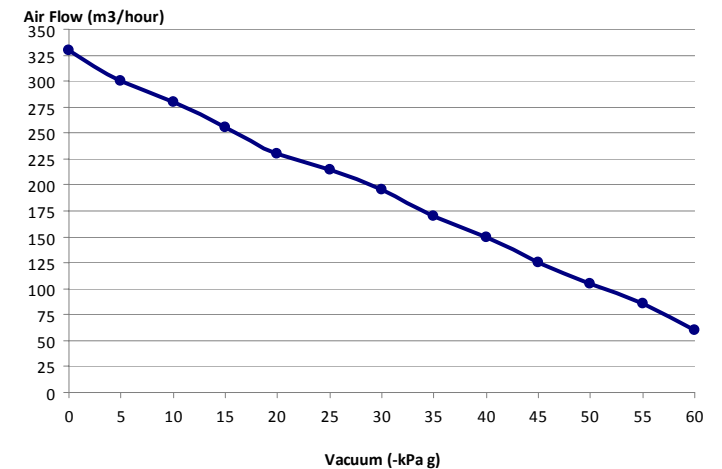
**Pilot Unit Performance  
With Cooling System and GAC in Exhaust Stream**
